Bluff's Creek Water Quality Improvement Plan Phase 1 Report

Submitted By: Kids for Turtles
Written By: Christine Pritchard, Project Biologist, Ontario Streams
Date Submitted: November 30, 2008

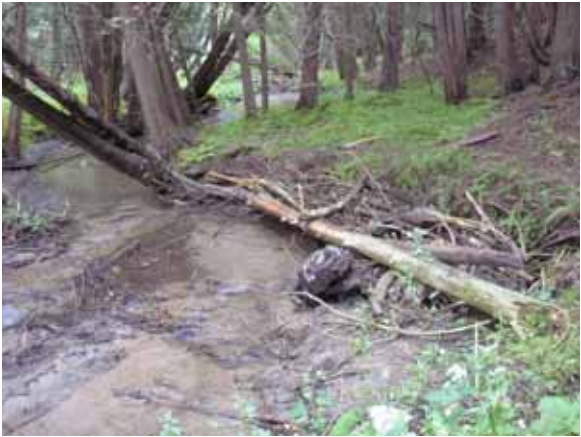
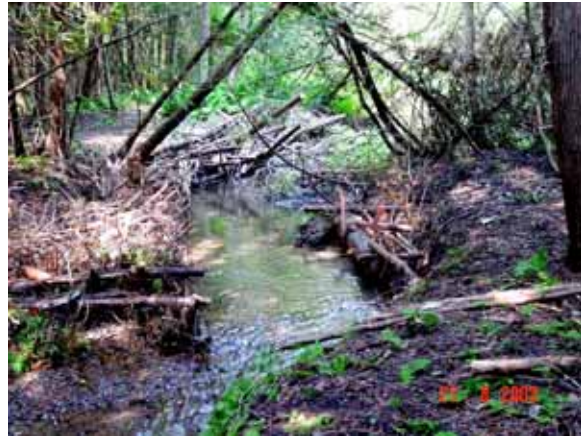
4. Several other bends through the middle section of this reach are experiencing minor to moderate erosion and have been recommended for securing in-stream woody debris in bends and/or live staking of willow and dogwood shrubs as described in #3 above. Their locations are identified in the rehabilitation plan included in Appendix A. The overall goal of this approach is to decrease erosion and sedimentation, and enhance fish cover within the creek by implementing structures with a natural-looking appearance. Examples of such structures are depicted in the photographs below.

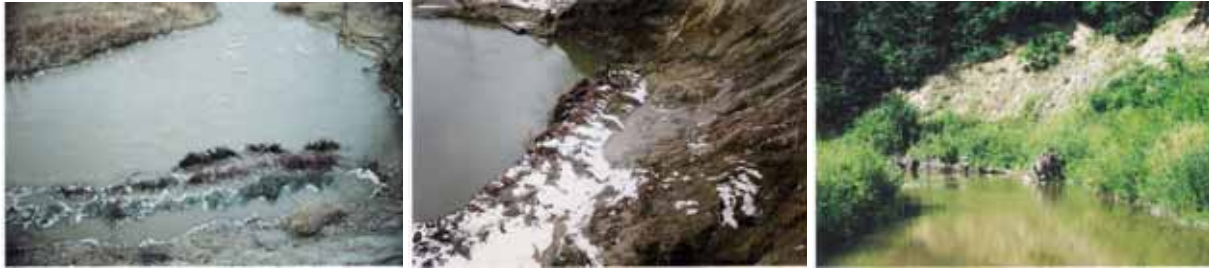
The series of photographs above show the progression of the East Humber structure.

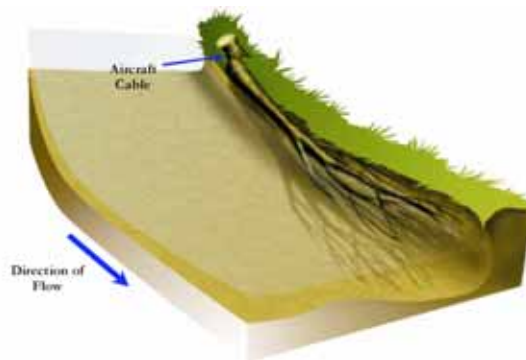
2. As previously stated above, as the creek flows through the section of cedar dominated forest, many of the banks are experiencing minor erosion. By using natural logs and fallen branches found on site, woody debris and cedar sweeps can be secured in these bends in such a way that they help to deflect the main force of the flow away from the vulnerable area. This method has been successfully used by Ontario Streams and its various volunteer groups in many stream rehabilitation projects. The debris can be installed in such a way that it appears quite natural as depicted in the adjacent picture. Live staking of the eroding stream bank in conjunction with the use of woody debris has also been suggested in one instance. It is suggested that cuttings from shade tolerant shrub species such as red osier dogwood or alternate leaf dogwood are implemented. These actions will help to prevent erosion, and thus limit the amount of excess sediment entering the stream, while also providing enhanced cover for local fish species.

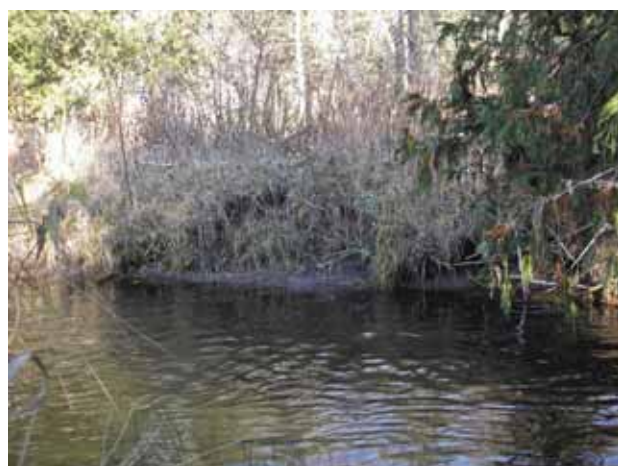
Photo 5: Slight erosion; re-grading and planting recommended

5. A minor eroding slope has been recommended for re-grading and subsequent shrub planting. Woody debris is first secured at the toe of the slope to protect any soil from entering the stream. The bank is then graded down over top of this material. By re-grading the vulnerable bank to a more gradual slope, the area will gain stability. The slope should immediately be seeded with an annual grass seed and covered with coir erosion control matting to provide short-term stability. The bank should then be heavily planted with willow shrubs to provide long-term stability.

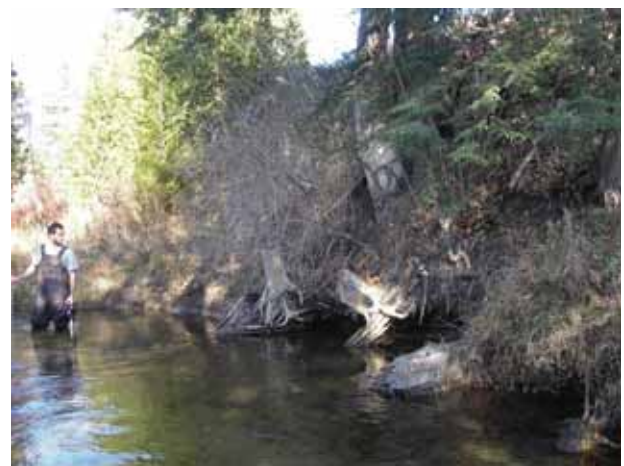
Photo 6: Steep eroding bank; debris jam recommended
