Bluff's Creek Water Quality Improvement Plan Phase 1 Report

Submitted By: Kids for Turtles
Written By: Christine Pritchard, Project Biologist, Ontario Streams
Date Submitted: November 30, 2008

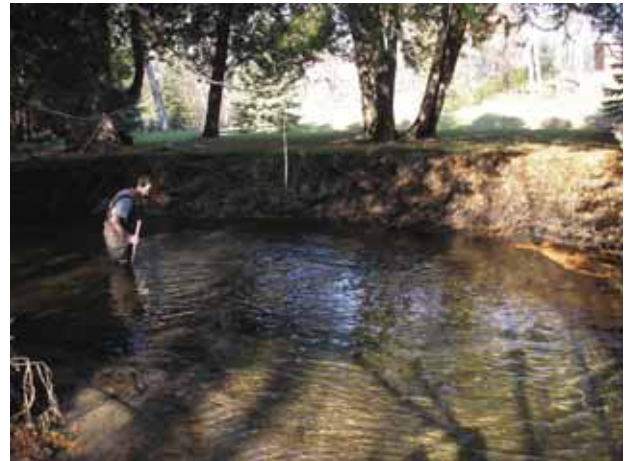
Photo 2: Steep eroding bank opposite man-made rock weir

head of the weir and the projection of the flow, much of the problem can be eliminated. In addition, the securing of woody debris, such as a fallen tree or large branches as cedar sweeps, in the bend can help to deflect further flow and provide additional protection to the bank. The woody debris will also act as overhead cover and habitat to local fish species. It is also recommended that some shade tolerant shrubs such as red osier dogwood and/or alternate leaf dogwood are planted on the bank in question as their root systems will further stabilize the soil.

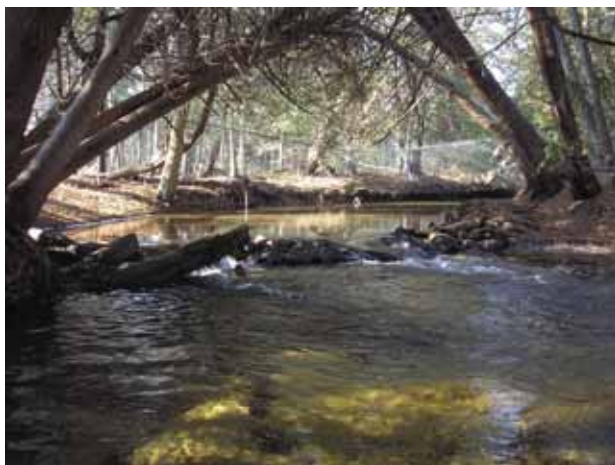
3. Moving upstream, the next noteworthy site is where a man-made rock weir has been built. As the stream cascades over this structure, it gains velocity and as a result is contributing to an erosion problem on the opposite exposed bank. By repositioning some of this rock to decrease the vertical

Photo 3: Man-made rock weir causing downstream erosion

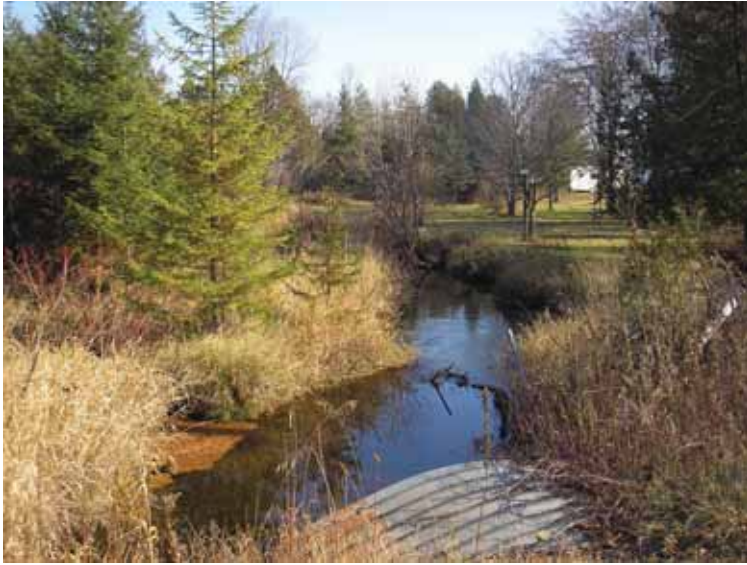
Photo 1: Bluff's Creek, looking downstream from Line 15. Extent of riparian buffer on each bank visible.
