Bluff's Creek Water Quality Improvement Plan Phase 1 Report

Submitted By: Kids for Turtles
Written By: Christine Pritchard, Project Biologist, Ontario Streams
Date Submitted: November 30, 2008

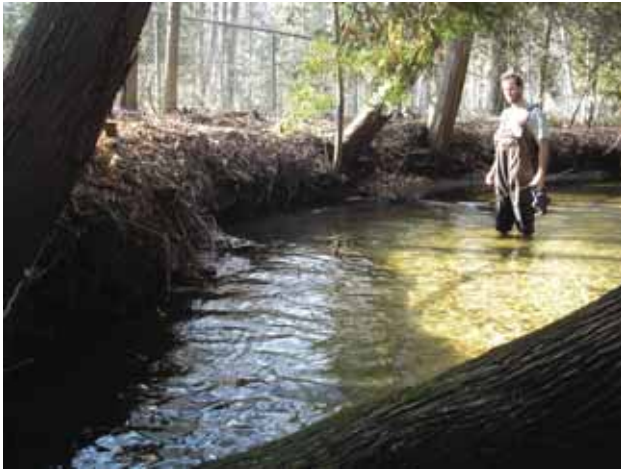
Photo 1: Slight erosion

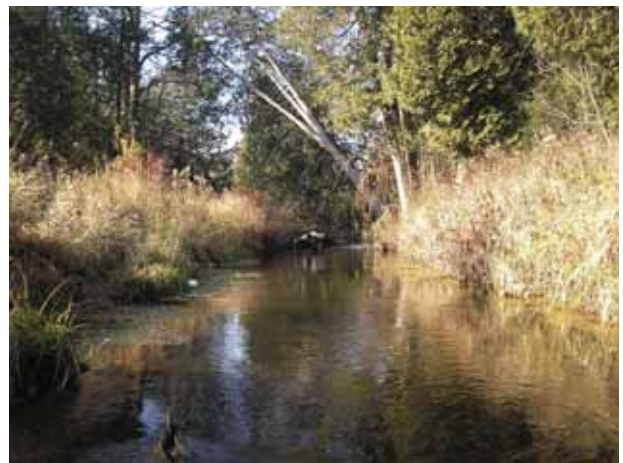
Photo 4: Watercress abundant stretch

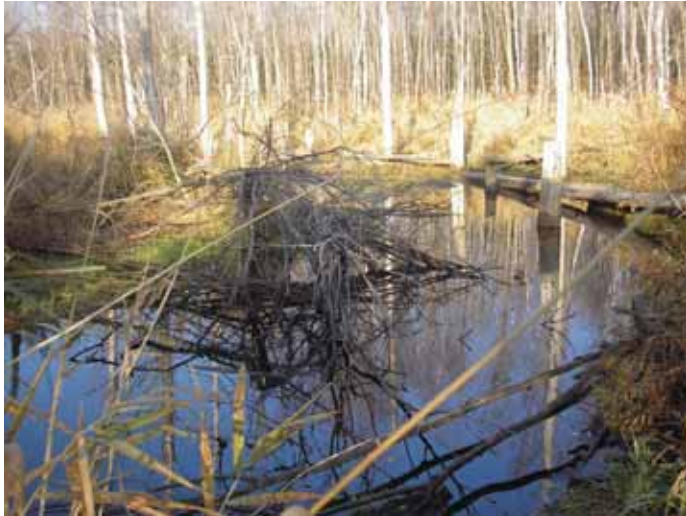
Photo 1: Abandoned beaver dam

5. The abandoned and degrading beaver dams should be removed in order to eliminate barriers to fish passage. The active beaver dams pose a larger problem. If an active beaver dam is dismantled it is

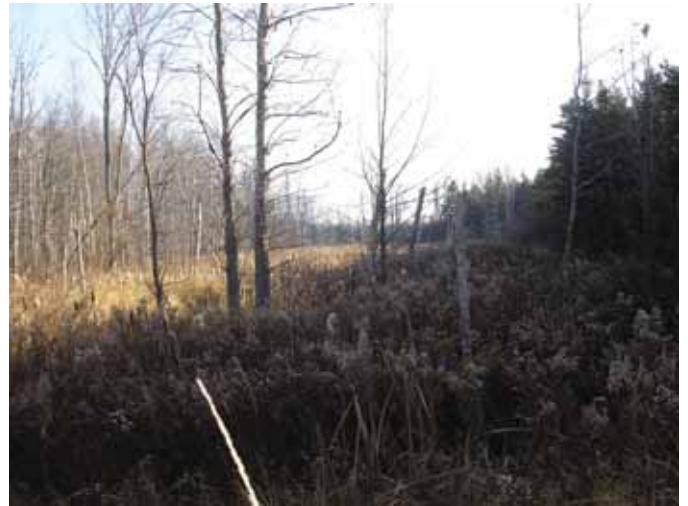
Photo 2: Wet meadow area between abandoned beaver dam and Line 15

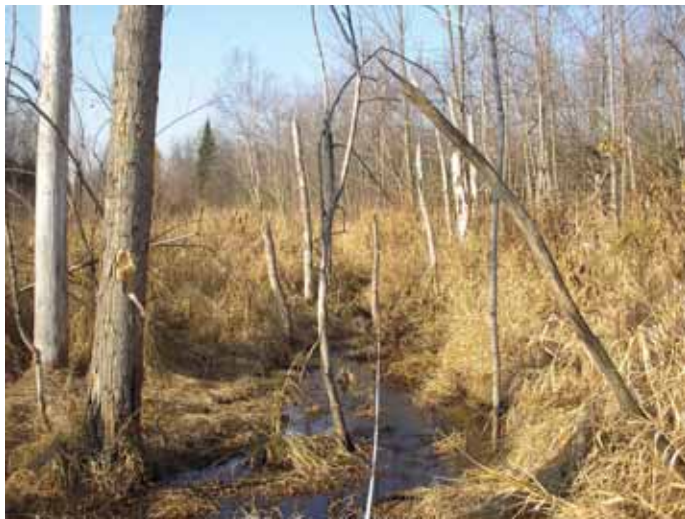
Photo 3: Undefined channel upstream of beaver pond

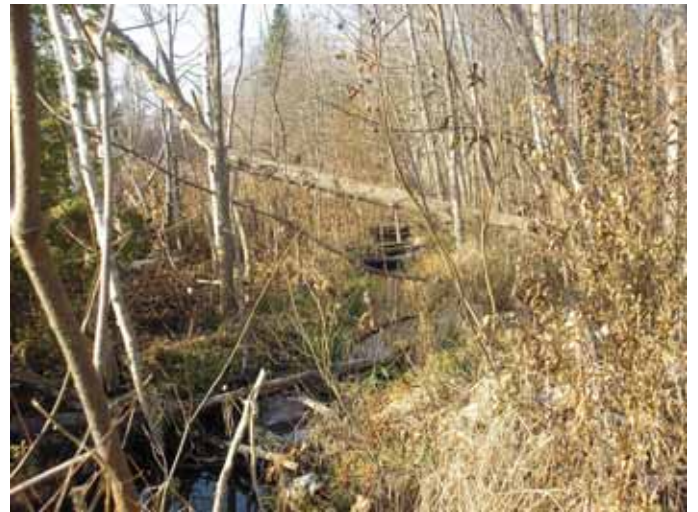
Photo 4: Beginning of defined channel section
